**INDEPENDENCE TOWNSHIP INVENTORY**

**Address** 6970 Andersonville Rd

**Original Usage** Boy Scout camp  
**Present Usage** Bay Court Township Park

**Site No.** 32-05  
**Sidwell No.** 08-32-301-002

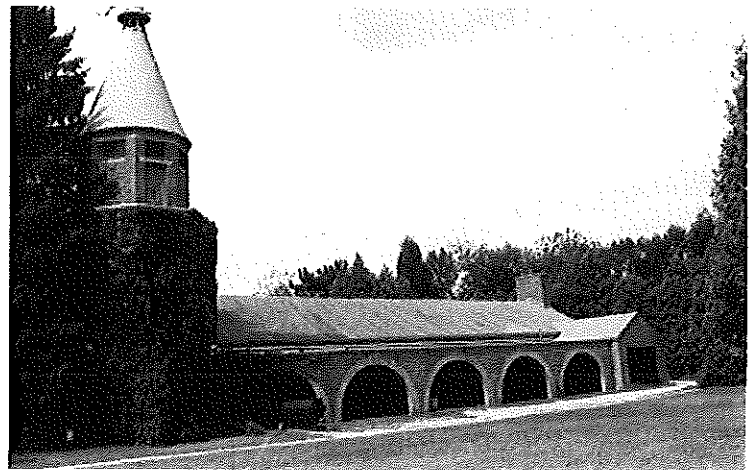
5. Brady Lodge

**Description** Boy Scout Lodge constructed of concrete block with red brick trim. This large building has an impressive circular tower, topped in copper. Also associated with the Boy Scout camp and located on the site are a concrete block garage (same block type as those used on the lodge) and four small log cabins. In 1937, the scout camp comprised 28.5 acres.

**Condition** all buildings-good to fair  
**Integrity** all buildings-good

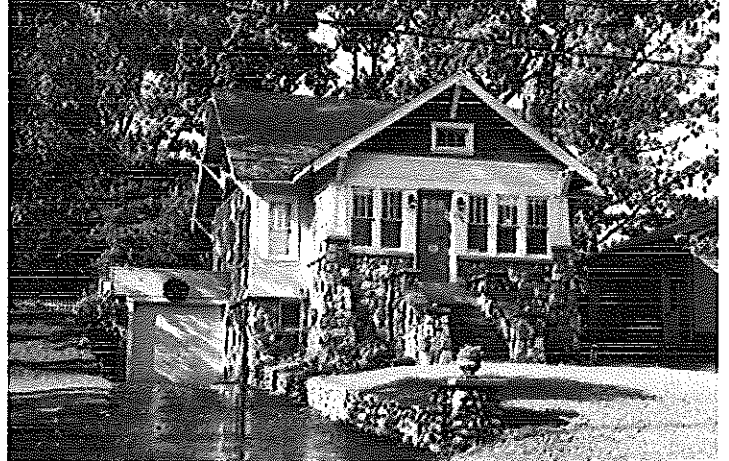
**Description** Craftsman style bungalow with an enclosed front porch, rubble stone half-walls and chimney, decorative braces under the eaves, and wood-shingled gables. An additional rubble stone wall is located along the east side of the driveway. Attached to the house is a one car-garage.

**Date of Construction** 1930  
**Condition** good  
**Integrity** good
