INDEPENDENCE TOWNSHIP INVENTORY

Address 8490 Ortonville Rd

Site No. 17-05
Sidwell No. 08-17-201-013

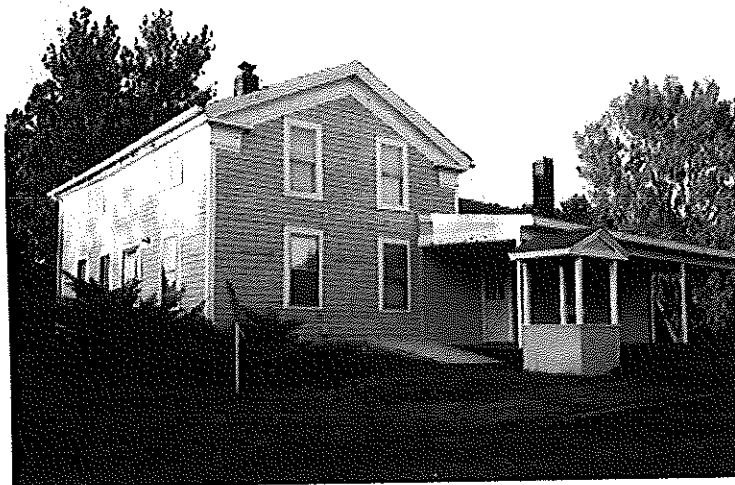
Description Side-gabled Greek Revival house with clapboard siding and a pair of frieze band windows. A one-story addition was constructed to the rear of the house. Also located on the site is a stone lined well.

Date of Construction ca. 1840
Condition good
Integrity good

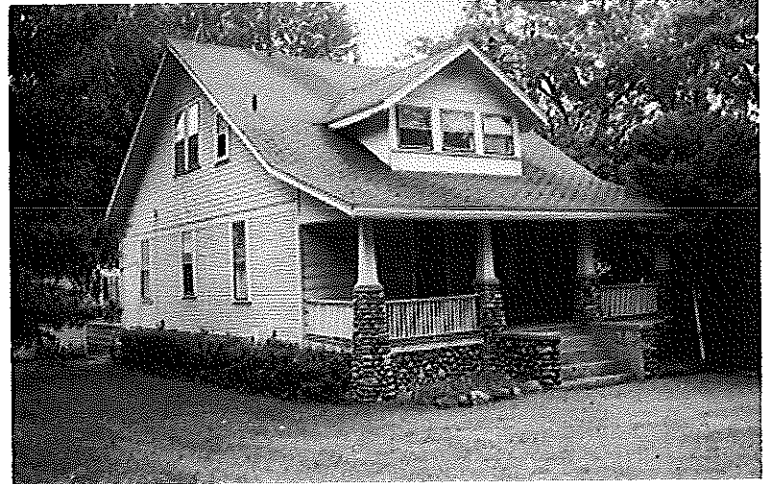
Site No. 08-03
Sidwell No. 08-08-400-025

Description One and one-half story bungalow with a gable roof (with dormer) and a covered front porch. The front porch, as well as the chimney on the south side of the house, are constructed of rubble stone.

Date of Construction 1924 (WPA Rural Properties Inventory), 1928 (township tax records)
Condition good
Integrity good

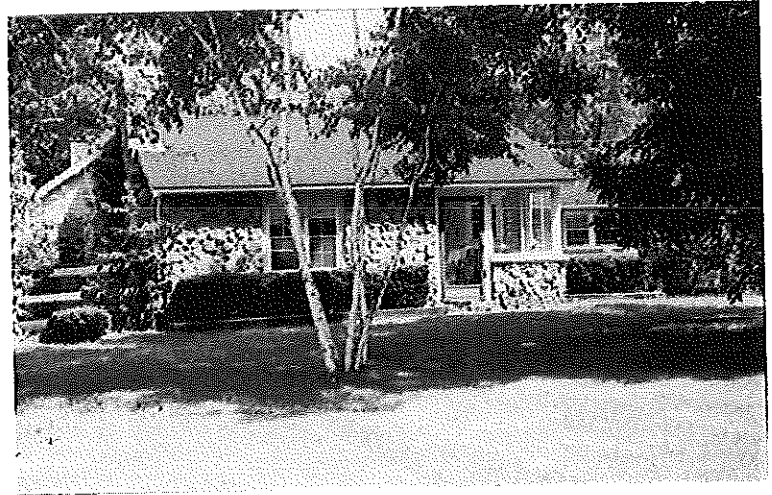
Site No. 08-02
Sidwell No. 08-08-400-001

Description One-story house with a rubble stone facade and chimney.

Date of Construction 1926
Condition good
Integrity good

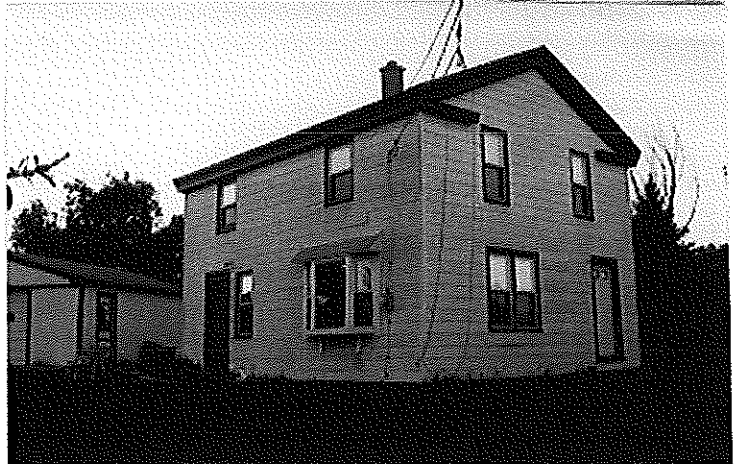
Site No. 05-03
Sidwell No. 08-05-300-041

Description Front-gabled house with many anachronistic changes including the concrete foundation, exterior siding, window replacements and relocations, and a small bay window.

Date of Construction 1880 (township tax records), 1938 (WPA Rural Property Inventory-remodel date or mistake for 1838?)
The returned cornice treatment of the front gable, and the pitch of the roof indicate that this house might date from the Greek Revival era, however, there have been many exterior changes, making the structure difficult to date.

Condition good
Integrity poor

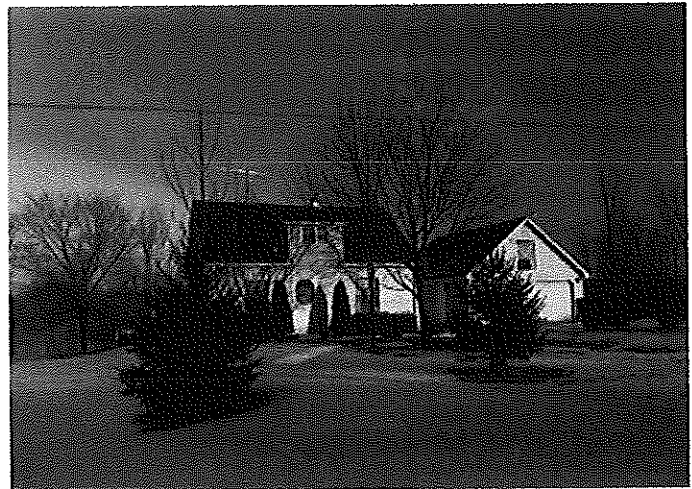
Site No. 05-01
Sidwell No. 08-05-451-011

Description One and one-half story side-gabled house with a cement block foundation. A two-car detached garage stands to the south of the house.

Date of Construction 1940
Condition good
Integrity good

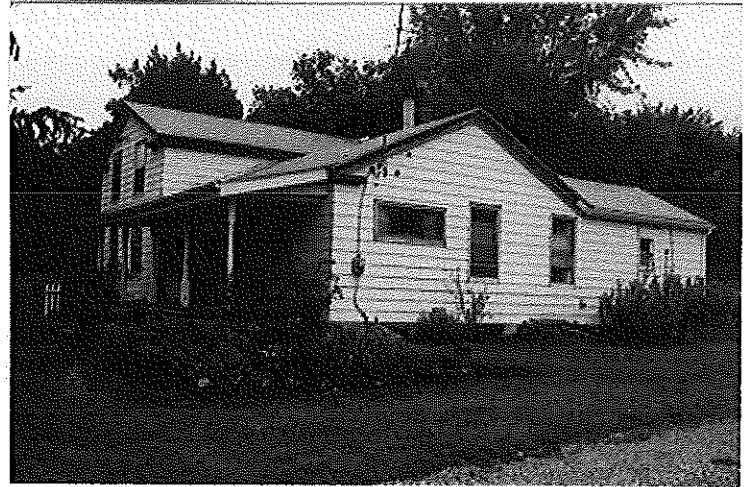
Site No. 05-02
Sidwell No. 08-05-101-031

Description Gable-front-and-wing Greek Revival house with a rubble stone foundation, and a covered front porch. The house lacks the wide trim band which typically emphasizes the cornice lines of Greek Revival houses. Additional anachronistic changes include aluminum siding and the front porch (concrete block foundation and turned porch supports).

Also located on the property, in back of the house, are the burnt ruins of a barn.

Date of Construction house-1850

Condition house-good; barn-ruins
Integrity house-fair; barn-poor
The house is located adjacent to a party store. This association detracts from the original rural quality of the property's landscape.
