INDEPENDENCE TOWNSHIP INVENTORY

Address 9662 Hadley Rd
Governmental Unit Independence Township
County Oakland
USGS Map Title Ortonville
Area Map Independence Fire Department
 Street Address Map - 2/14/96
Original Usage Farmstead
Present Usage Single-family residence
Ownership Michelle Ann Zielinski
Photography
Roll: Frame No. 7:19 2:16
View of Photo E SW
Date of Photo 9/98 8/98
Surveyor/Date D. Dietrich-Smith/Aug 8-12, 1998
Recorder/Date D. Dietrich-Smith/Aug 27, 1998

Site No. 08-01
Sidwell No. 08-08-200-038

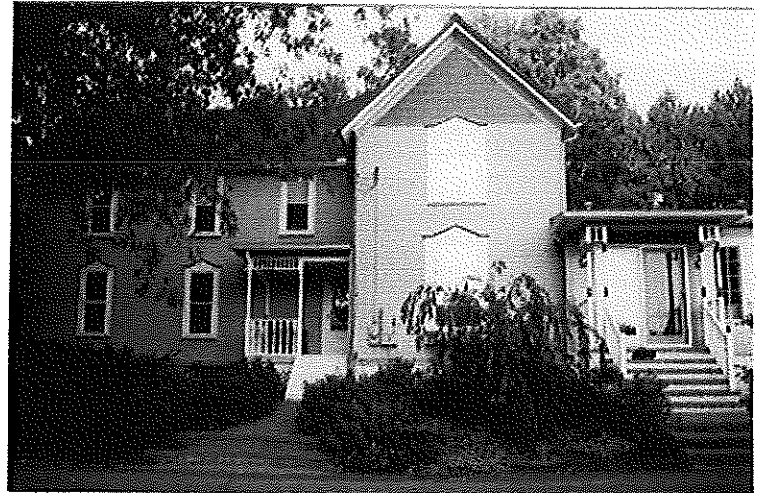
2. Residence

Description Two-story L-plan house with a granite foundation and double-hung attenuated windows with gabled lintels. The foundation from the house dates from 1853 and is the only surviving feature of the original house which burnt down sometime during the 1880s. A porch in the corner of the 'L' has decorative spindle-work and balustrades. A porch addition to the southwest of the house was made in 1988, and a two-story wing addition was made to the east in 1994.

Date of Construction house-1892, barn-1853, garage-unknown
Condition house-good; barn-good, garage-good
Integrity house-good (Although the recently completed addition has significantly alters the integrity of the house, the house is still considered to have good integrity because it is one of the few houses in the township with a significant amount of original exterior architectural embellishments.)

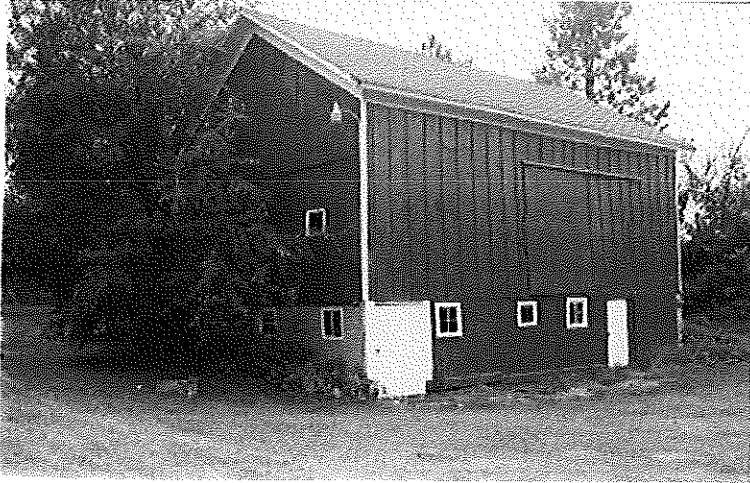
9. Barn

Also located on the property is a barn with a gable roof and rubble stone and concrete foundation. Just to southwest of the house is a detached two-car garage.

barn-good, garage-good

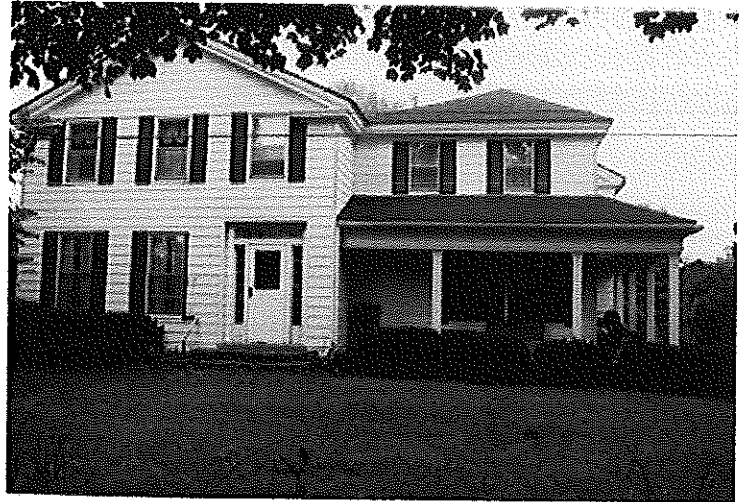
4. Residence

Description Front-gabled two-story Greek Revival house with a rubble stone foundation, a covered wrap-around porch and distinctive transom and side lights surrounding the front door. Anachronistic elements include aluminum siding and decorative shutters.

Date of Construction house-1875; barns-may date from ca. 1875. (A gable roofed barn 30x60' with stone foundation was identified on the WPA 1939 Rural Properties Inventory.)

Condition house-good; barns-fair.

Integrity house-good; main barn-good; secondary barn-fair (garage door addition).
farm landscape-good (mature plantings, several farm structures, rural road).

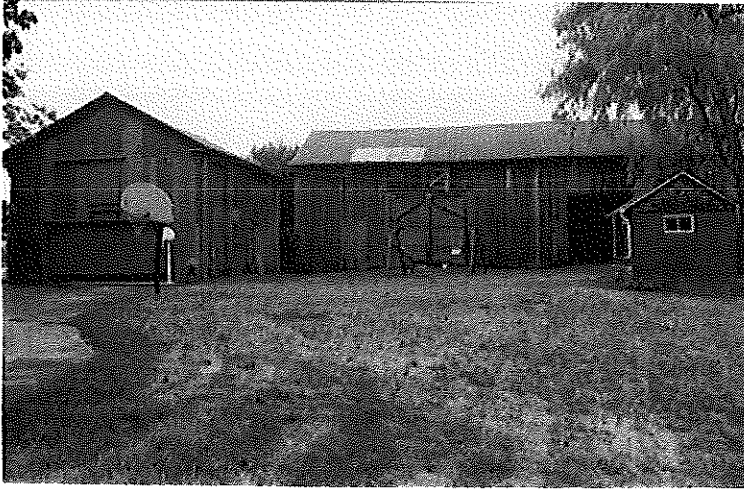
5. Two barns and small concrete block building (E)

Several farm buildings are located on the property including two barns with gable roofs and a small concrete block outbuilding, possibly a well house or a milk house.
